March 14, 2013

WORKING GROUP 3

E9-1-1 Location Accuracy

Indoor Location Test Bed Report

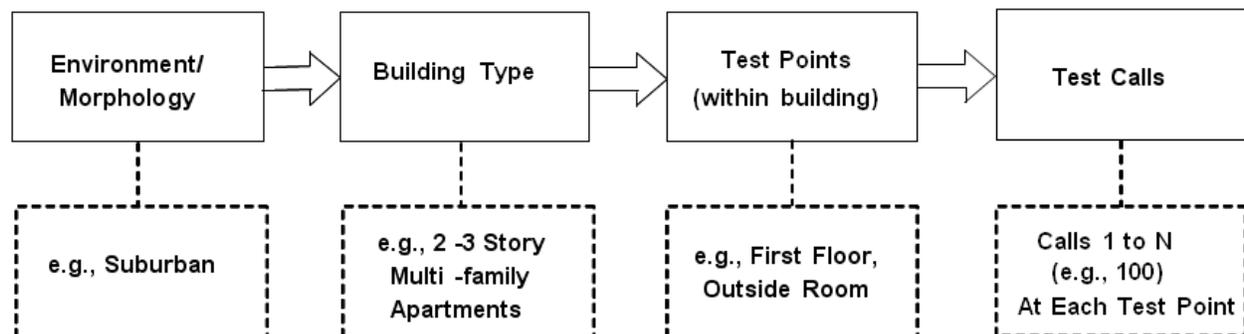
Figure 6.1-1. Morphology, Building and Test Point Flow Down

In each morphology (or broad wireless use environment) a number of buildings of different sizes and types common in that morphology were identified. Within each building, different test points were selected to represent the range of conditions encountered within that building. The number of test points in a given building depended on its size and complexity. At each test point a statistically significant number of independent test calls was placed. This logical flow-down is shown in Figure 6.1-1.

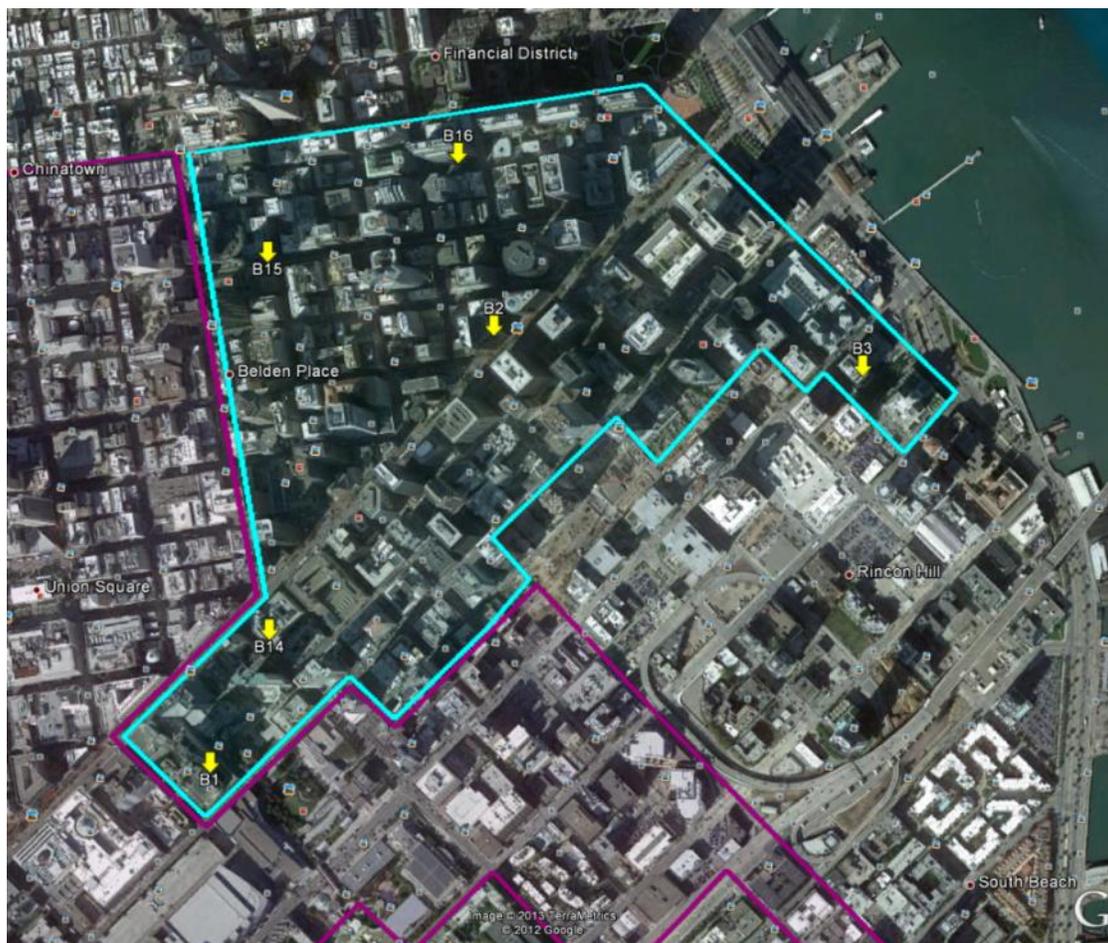
Figure 6.3-1. Relative Locations of the Test Buildings Used in the Dense Urban Morphology

The dense urban polygon used is shown in Figure 6.3-1. It consisted primarily of the financial district of San Francisco and its immediate vicinity of high rise buildings.

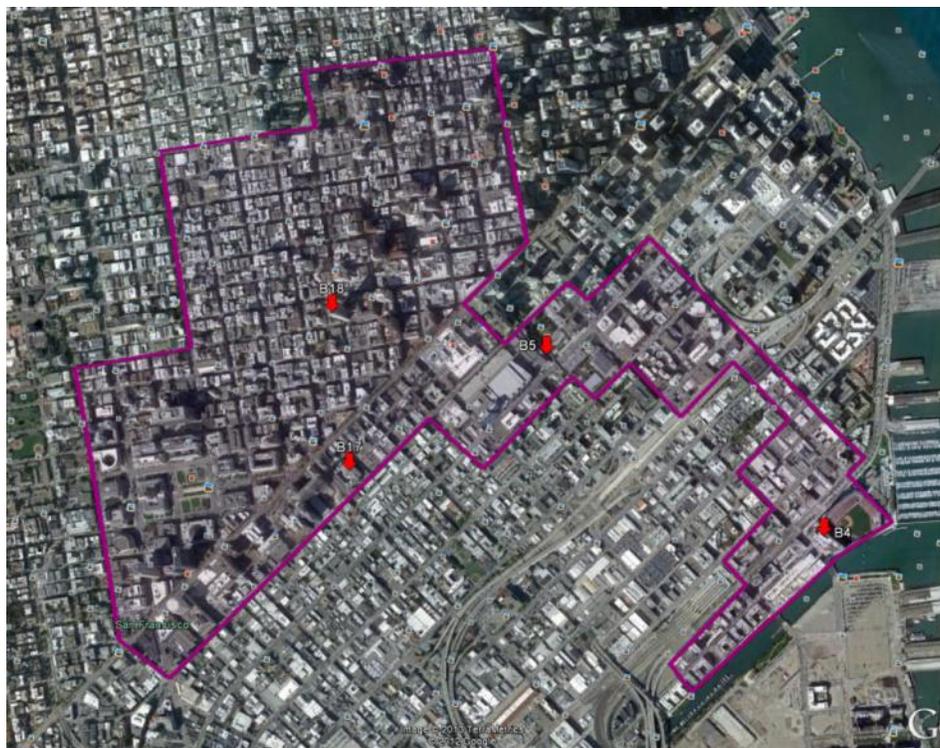
Figure 6.3-3. Urban Polygon in San Francisco and Relative Locations of the Test Buildings

The urban polygon in San Francisco is shown in Figure 6.3-3. It contains varied building densities and construction types that range from larger commercial buildings (near the downtown dense urban polygon), to older mixed-use neighborhoods with medium and smaller sized buildings (both commercial and residential in the middle of urban clutter), as well as newer, redeveloped areas with medium height residential and commercial buildings, city government buildings, and a large stadium. The San Francisco urban polygon is typical of an “older urban” area with densely packed construction (regardless of building height), somewhat narrower streets, and similar or narrower building separation than the dense urban polygon.

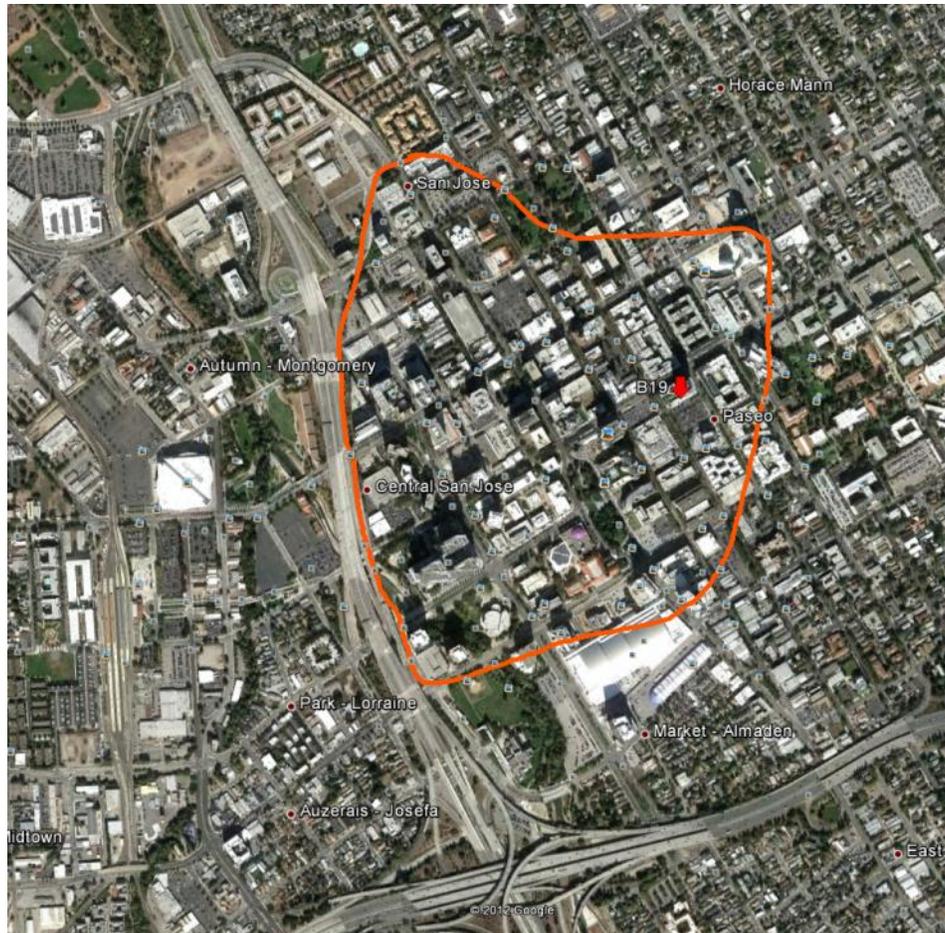
Figure 6.3-4. Urban Polygon in San Jose

The urban polygon in San Jose is representative of “newer urban” development, with a downtown typified by tall buildings of up to 30 stories, but with somewhat wider streets and somewhat greater building separation than in older urban or dense urban morphologies. It is depicted in Figure 6.3-4.

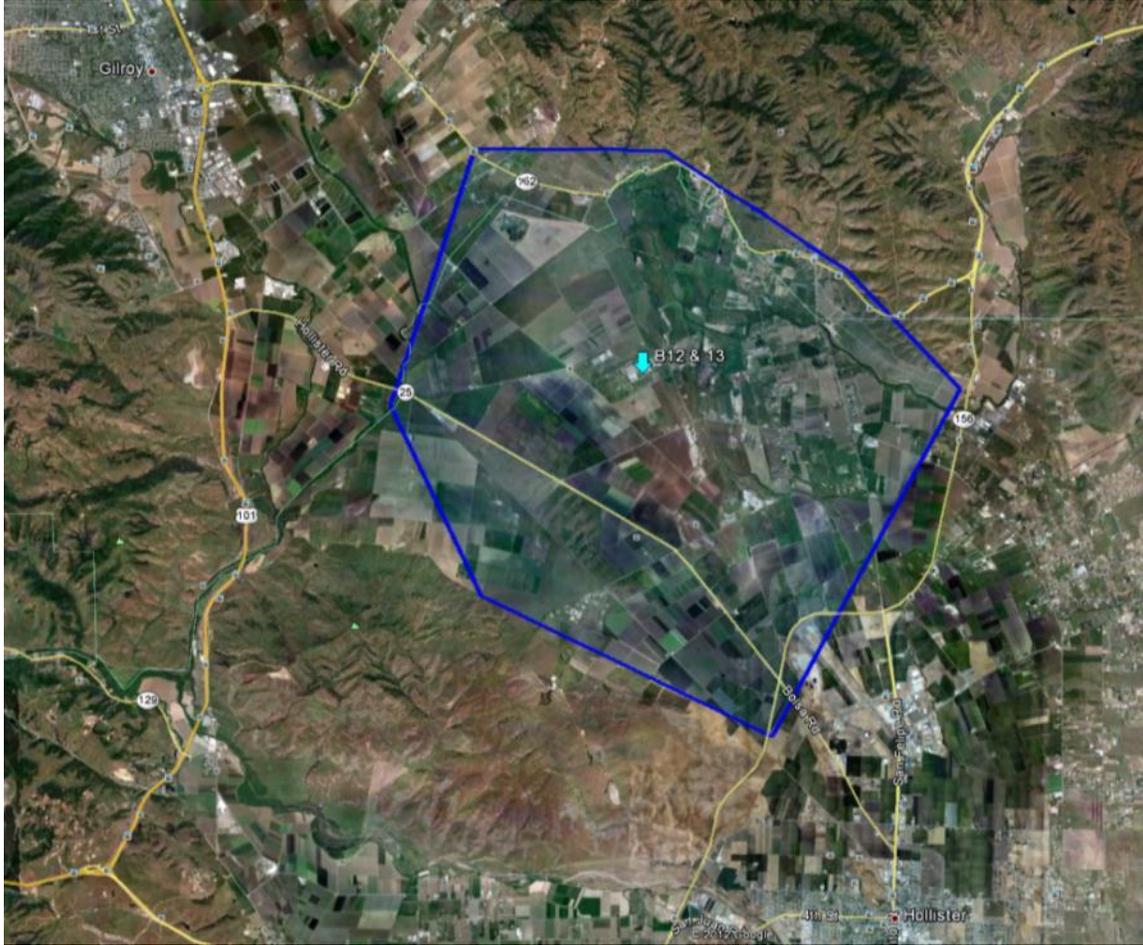
Figure 6.3-8. Rural Polygon and Location of Buildings Used

The rural polygon is located in the area between Gilroy and Hollister and is depicted in Figure 6.3-8. It is characterized by large farming tracts, isolated residences and limited commercial development. Of particular note is the low density of cell sites due to distances and the intervening terrain on the periphery of the area. The low cellular site density was a key factor in the selection of this polygon, which is about 40 miles south of downtown San Jose.

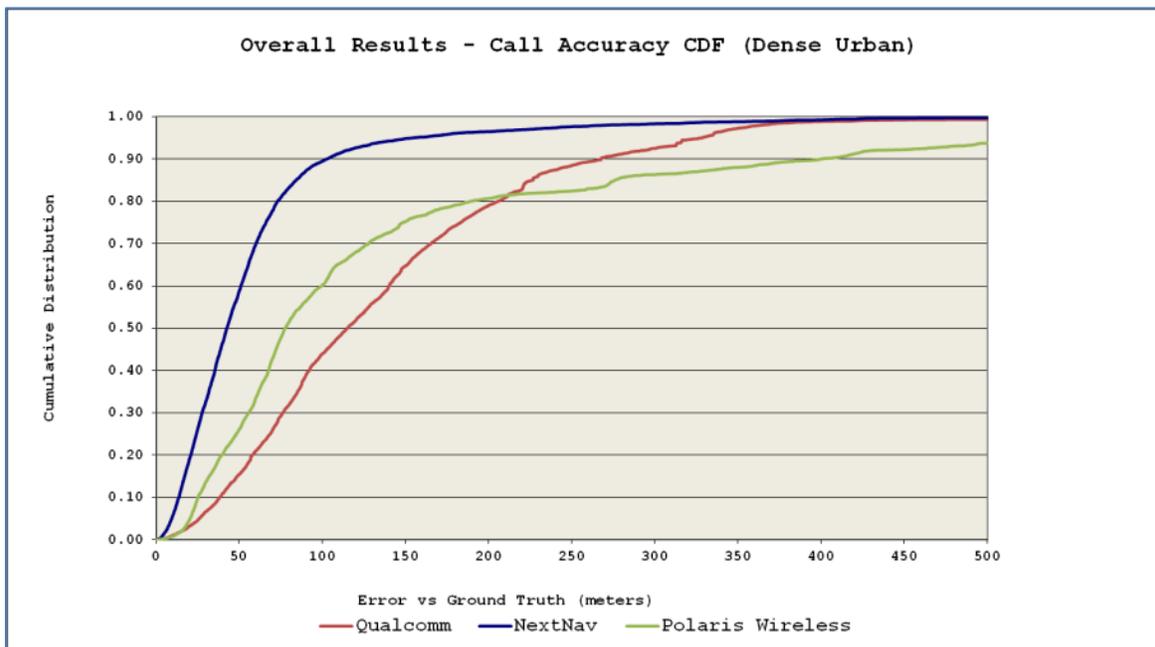
Figure 7.3-1 Cumulative Horizontal Accuracy in the Dense Urban Environment

The following are the results aggregated over buildings BD1, BD2, BD3, BD14, BD15 and BD16, all in and around downtown San Francisco.

The results for the dense urban buildings highlighted the challenges that satellite signals have in penetrating to those points that are in the interior of large buildings. Consequently, AGPS fall-back modes, such as AFLT, were experienced frequently. Accuracy degraded as expected when GPS fixes were not attained. While a surprising proportion of hybrid fixes were experienced, even at test points where one would not expect a satellite signal to penetrate, the quality of the hybrid fixes was in general significantly degraded compared to GPS fixes. Hence, in many dense urban test points (and in urban buildings as well) a significant amount of spread in location fixes was observed. This often extended over a number of city blocks. Few very poor fixes are seen in the dense urban case, perhaps because the high cell site densities (and consequently small cell radii) in the dense urban core create a reasonable lower bound on fall-back accuracy.

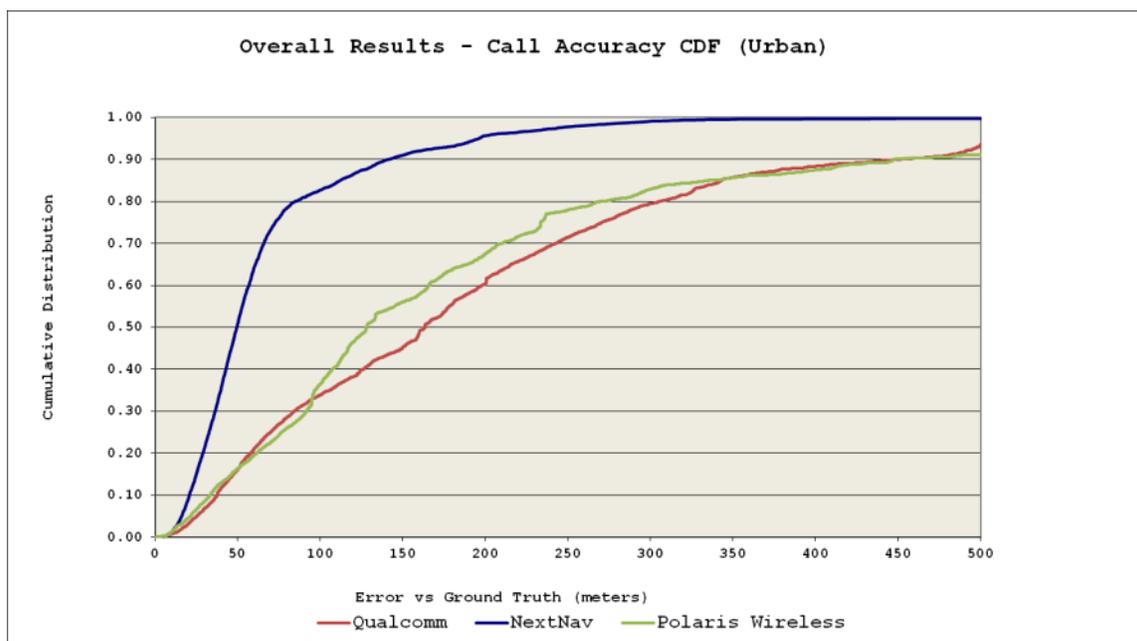
Figure 7.3-3 Cumulative Horizontal Accuracy in the Urban Environment

As mentioned earlier, the specific test buildings used in the urban morphology were challenging, each in their own way. This is because each building represented more distinctly a building type and setting than the high rises of the dense urban environment.

The baseball stadium by the San Francisco Bay (BD4, AT&T Park) created a situation where AGPS fallback fixes could be very far away due to the very exposed RF propagation outside the structure in which the test points were located. This impacted points that were relatively deep inside the stadium building. The structure of the stadium also appears to have created challenges to RF fingerprinting at some test points.

The convention center created in some cases an environment that was deep indoors but with very strong cellular signal from cell sites inside the building (including a DAS). This situation was captured by two points of different depth (BD5_TP2 and BD5_TP3). This situation resulted in the beacon-based location system performing poorer than in most other test points, since attenuation to different directions in the outside world was particularly strong in those scenarios. AGPS and RF fingerprinting relied on the cell sites inside the structure to create adequate location fixes.

The US Court of Appeals Building (BD17) represented a classic older, heavy construction, but also had a very large atrium in its middle. Results varied depending heavily on the degree of distance from windows or the central atrium. Again, the phenomenon of apparent location in a building across the street is seen here (e.g., BD17_TP2 for both NextNav and Qualcomm, which was a test point inside a large court room with windows in the direction of the building across the street). As one would expect, the degradation caused by being away from a window or atrium more significantly impacted the satellite based system than the terrestrial beacon based one. RF fingerprinting fixes appeared to cluster about the larger reflectors in this urban corner of San Francisco, which happened to be mostly across the streets from the target building.

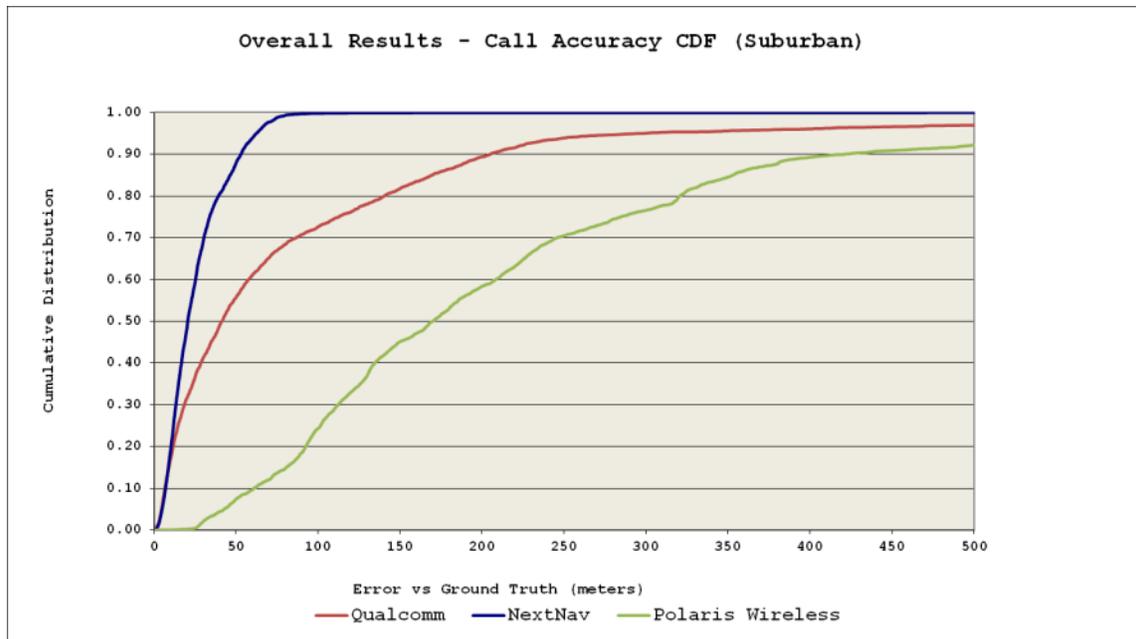
Figure 7.3-5 Cumulative Horizontal Accuracy in the Suburban Environment

The following are the results aggregated over buildings BD6, BD7, BD8, BD9, BD10 and BD11 in Santa Clara and Sunnyvale.

The effect of smaller buildings with lighter construction and more spacing between buildings is immediately evident on the quality of the location fixes in the suburban environment. This is most clearly demonstrated in the case of individual houses or small apartment buildings. Outstanding GPS performance, almost as good as outdoors, can be achieved inside single story homes (see BD8). The majority of the GPS fixes fall inside the small home or its small lot. Almost as good a performance is achieved inside the upper floor of relatively small buildings with composite or tile roof material (see BD10_PT1, BD11_PT1). CDF's that are tightly packed at small error values (well below 50 m) signify this type of outstanding performance. Similarly outstanding performance is achieved on average by the beacon based location technology under similar circumstances. RF fingerprinting appears to suffer from performance degradation compared to more dense morphologies in the city. It is able to identify only the part of the neighborhood where the test calls originated, with spreads over a few to several blocks, and fixes that are frequently clustered or spread along roads where calibration was performed (e.g., BD8, BD9, BD10).

The AGPS performance predictably changes as the suburban buildings become bigger and higher. Test points that are not on the top floor have significantly more positioning error and spread about them as fall-back modes are more frequently the solution. The terrestrial beacon-based network continues to perform well in the larger suburban buildings (e.g., BD6, BD7). The phenomenon of positioning at the nearest building is only occasionally seen (basically when the propagation physics force it to happen, which is not common in the suburban environment). One example where this is seen is the parking structure (BD7_PT5) where the location signals are forced to tunnel through the garage entrance and bounce off the side of the adjacent building. Curiously, GPS appears to perform well in this specific scenario, perhaps because the parking structure had only 2 floors. RF finger printing shows some enhancement relative to the smaller suburban buildings, but still shows most of the location fixes along the roads, highways or reflecting buildings.

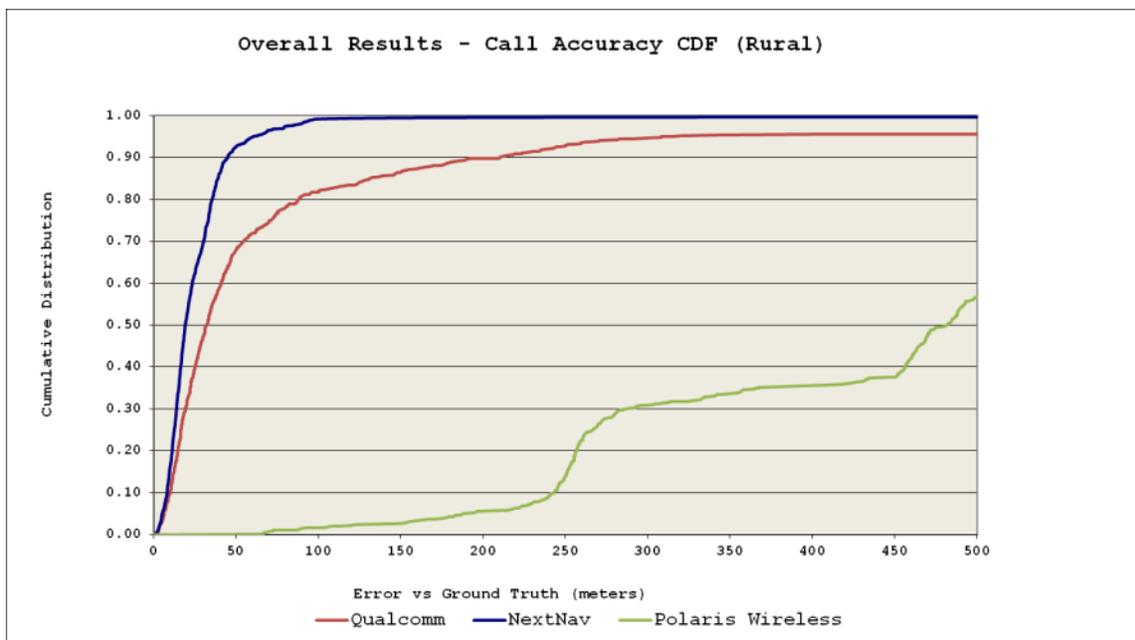
Figure 7.3-7 Cumulative Horizontal Accuracy in the Rural Environment

The following are the results aggregated over buildings BD12 and BD13 in the rural area north of Hollister, CA.

As mentioned earlier, the buildings chosen for the rural environment were limited by what was accessible in the available time. Both buildings selected were large one-story structures with metal roofs. Performance of AGPS reflected the effect of the metal roof and some metal siding in limiting the available number of satellite signals available for trilateration at certain test points. In these cases more hybrid fixes were experienced with a concomitant increase in the spread of the location fixes about the true location (e.g., BD13_TP2 and to a lesser extent BD12_TP1). In easier rural scenarios where metallic surfaces or multiple floors are not present, e.g., in a rural house, the expected performance would be very good similar to that seen in a suburban home, like BD8, or a small structure like BD11.

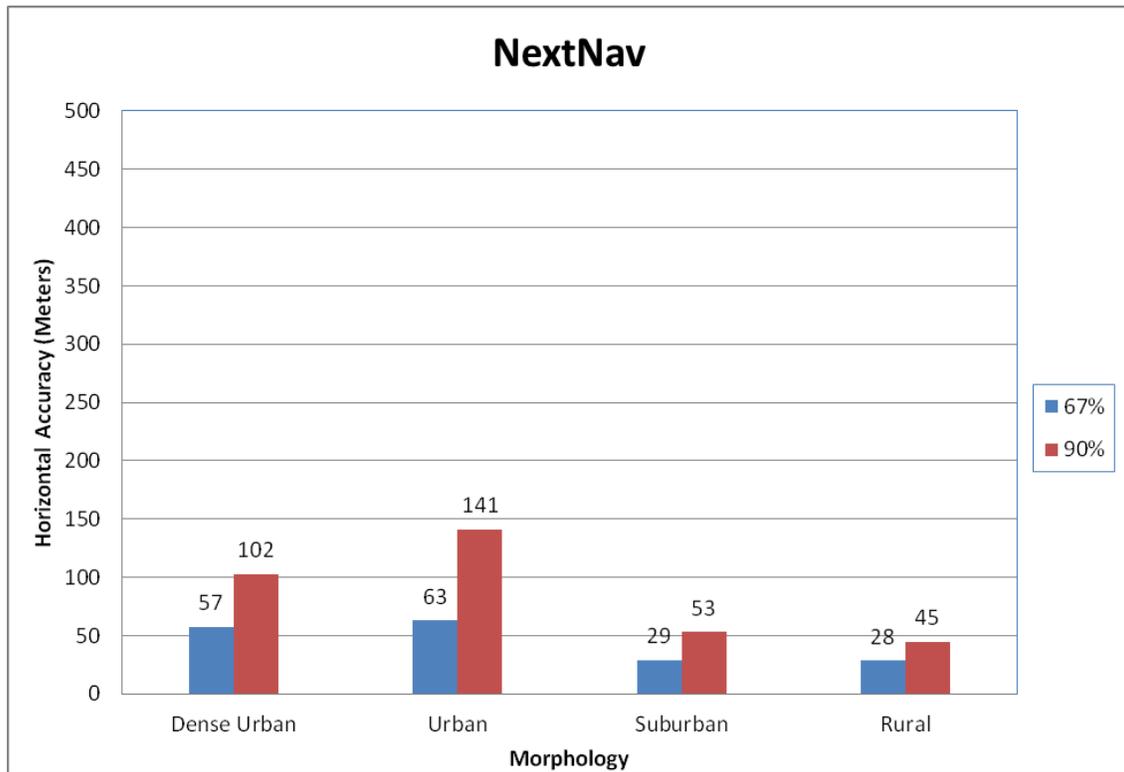
Figure 7.4-1. Indoor Accuracy by Morphology for NextNav

The following charts provide a quick view summary of the horizontal accuracy percentiles for each technology across the four morphologies.
